### TRIP REPORT

Destination: Schenectady Works, Buildings 8 and 17  
Dates of Contacts: January 5th and January 18, 1955  
Contacts made by: Robert Bryant  
Elliott Krackhardt  
Persons Contacted: Mr. H. F. Zaiss  
Mr. Davidson  
Mr. Pickney  
Purpose of Trip: To determine physical changes brought about by hydrogen firing 21" frames.

Results: Flatness of frames was distorted by 20 - 30 mils when hydrogen fired at 700, 900 and 1100°C.

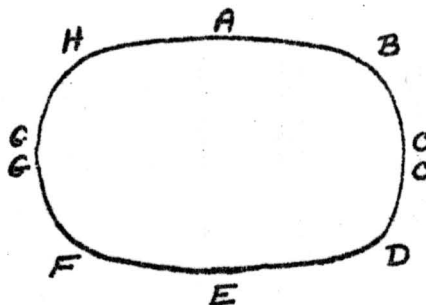
Furnace Temp*	Frame No. #	Condition of frame	AE**	GC	A	B	C	D	E	F	G	H
700°C	1	before prestressing	13.745	18.620								
		after prestressing	13.715	18.640	0	2	3	3	1	0	2	3
		after regrounding			0	1	2	1	0	1	1	1
		after firing	13.733	18.627	14	0	7	10	18	10	0	6
	4	not prestressed	13.749	18.618	1 1/2	0	0	0	0	1	0	0
		after firing	13.747	18.613	13	0	6	10	19	12	0	5
900°C	3	before prestressing	13.752	18.613								
		after prestressing	13.722	18.630	0	3	3	3	1	0	3	4
		after firing	13.678	18.628	5	0	1	2	11	18	1	4 1/2
	5	not prestressed	13.740	18.621	2	1	0	0	0	2	0	1
		after firing	13.711	18.615	5	1 1/2	1	3	10	9	6	1
1000°C	2	before prestressing	13.745	18.620								
		after prestressing	13.710	18.637								
		prestress removed	13.747	18.616								
		prestressed again	13.715	18.631	0	5	5	5	2	2	4	5
		after regrounding			1 1/2	0	1	1	0	0	0	1
		after firing	13.684	18.608	17	0	0	8	30	24	5	3
	6	not prestressed	13.746	18.620	1	0	1 1/2	1 1/2	0	2	0	1

after firing	13.750	18.588	16	0	1	1	2	11	3	1

Notes: \* Firing schedule given in General portion of this report  
 \*\* The lettering in the table is as follows.
